UNITED STATES
NUCLEAR REGULATORY COMMISSION
OFFICE OF NUCLEAR REACTOR REGULATION
WASHINGTON, D.C. 20555-0001

NRC INFORMATION NOTICE 95-04, Supplement 1: EXCESSIVE COOLDOWN AND DEPRESSURIZATION OF THE REACTOR COOLANT SYSTEM FOLLOWING LOSS OF OFFSITE POWER

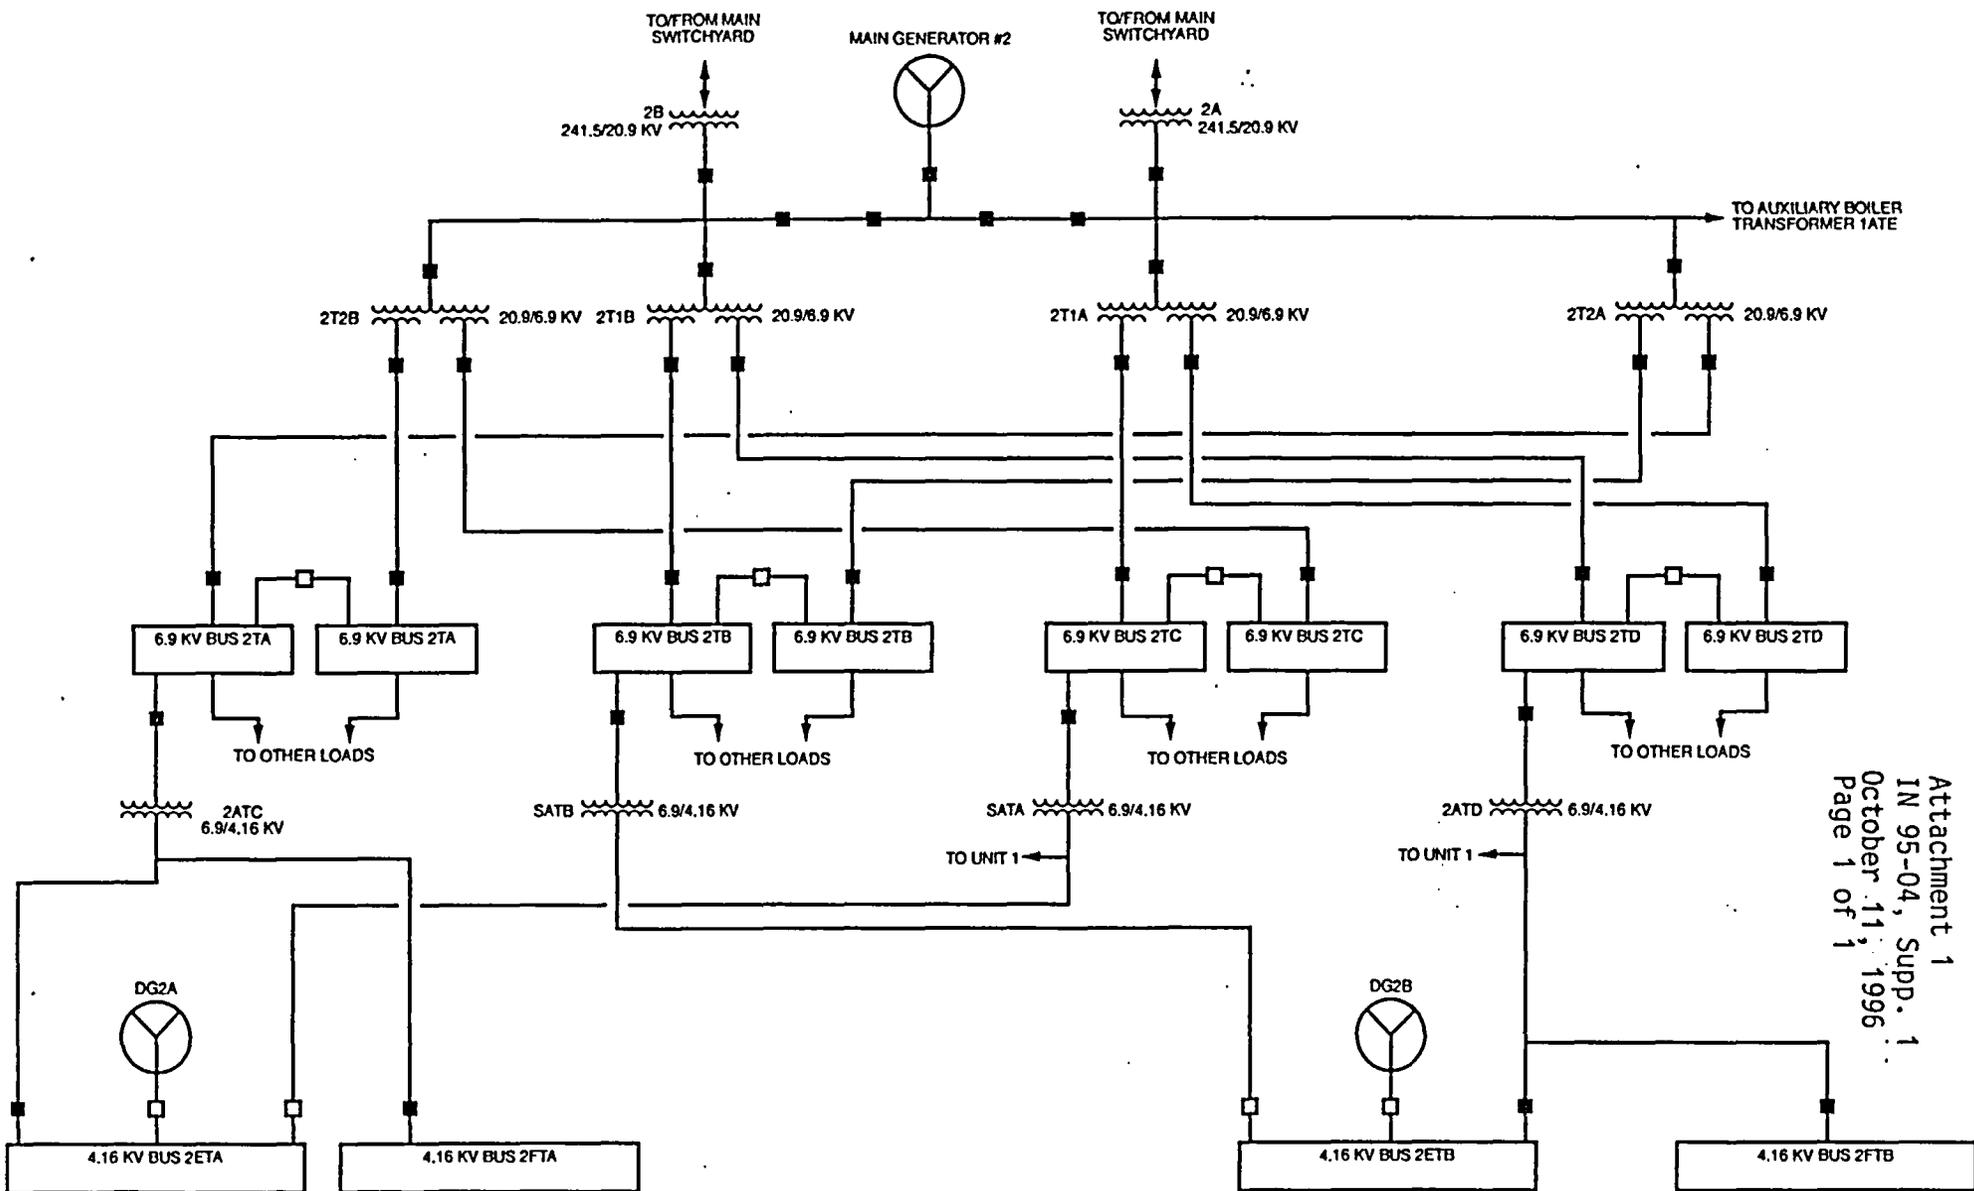
Figure 1. Catawba 2 Electric Power Distribution System

The main generator at Catawba Unit 2 normally supplies power to the onsite electrical distribution system through auxiliary transformers. Power to the offsite electrical grid is supplied by way of two half-size stepup transformers (designated 2A and 2B) using a dual-output circuit-breaker design (Figure 1). When the main generator is shut down, the two output circuit breakers are opened and offsite power is supplied (backfed) to onsite loads by means of two separate circuits via the two stepup transformers. An isolated-phase bus system connects the generator and transformers.

A loss of offsite power and safety injection occurred at Catawba Unit 2 on February 6, 1996, when two potential transformer resistor bushings in the 22-kV isolated-phase bus system simultaneously shorted to ground. This caused a phase-to-phase fault that resulted in a generator lockout followed by a turbine trip and reactor trip. The lockout interrupted power supply to the 22-kV isolated-phase buses 2A and 2B and led to the loss of offsite power.
